INDOOR AIR QUALITY ASSESSMENT

**Rowlandson Elementary School
103 Hollywood Drive
Lancaster, MA**

Prepared by:
Massachusetts Department of Public Health
Bureau of Environmental Health
Indoor Air Quality Program
July 2017

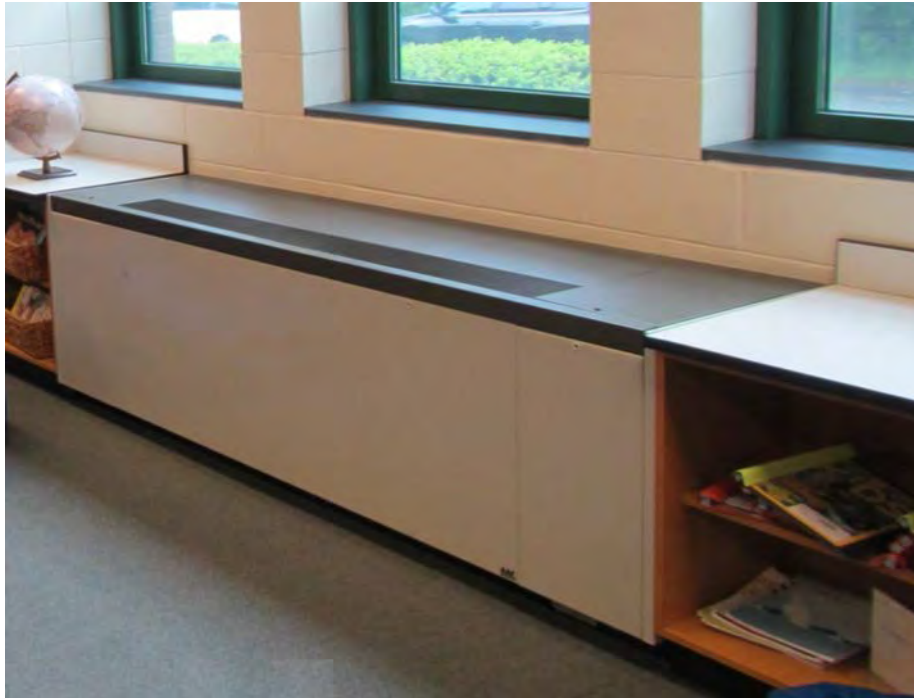
Picture 1

Fresh air is provided by unit ventilators (univents) located in classrooms and the Library space (Picture 1). The unit ventilators draw fresh air through a vent on the exterior wall (Picture 2). Air is mixed with return air from the room, filtered, heated or cooled (if needed) and delivered back to the room ([Figure 1](#)). Exhaust vents are located on the ceilings of rooms (Picture 3) and are ducted to fans on the roof. The exhaust vent in classroom B116 was noted to be off during the assessment.

Unit ventilator (uninvent)

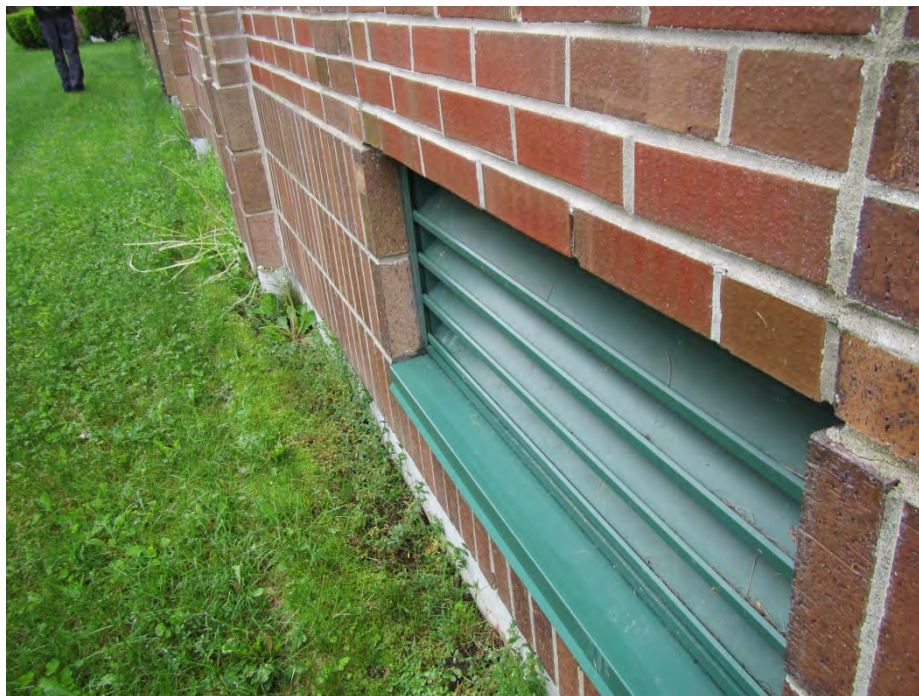
Picture 2

Univent fresh air intake vent (note vent is properly recessed in brick frame)

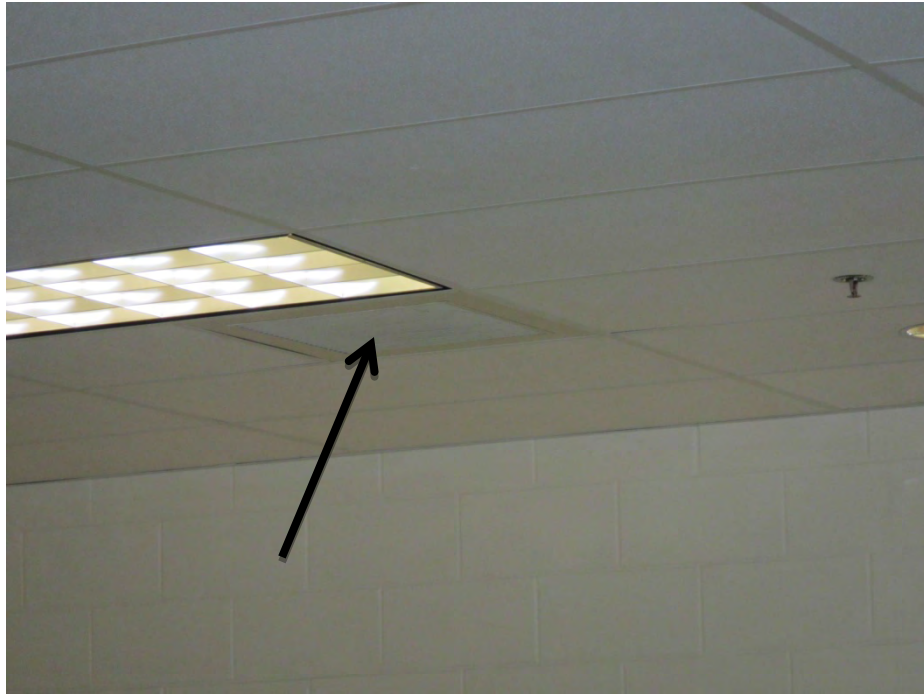
Picture 3

Ceiling-mounted exhaust vent (arrow)

8. Ensure exhaust vents are working properly (B116 was off). Operate all supply and exhaust ventilation equipment continuously during occupied periods.

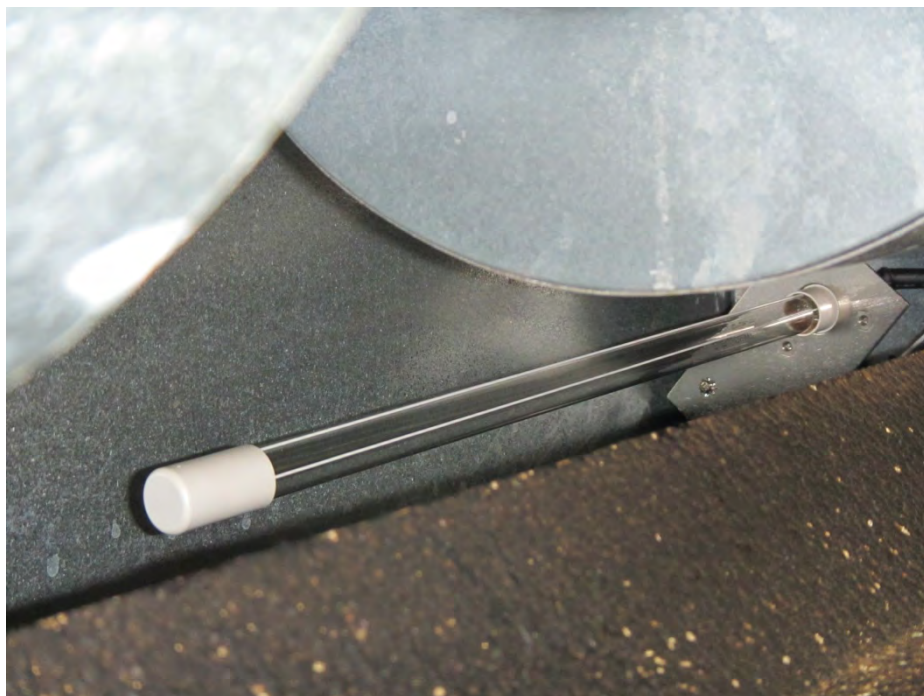
Picture 4

As mentioned, UV sterilization bulbs were installed in the B116 univent cabinet. They may be effective in killing certain types of bacteria. However, even if mold spores are killed they can still cause allergenic effects to occupants. Depending upon the wavelength of the UV bulbs, they may also produce ozone, a known lung irritant. Further, these bulbs do not address the root source of any odor or microbial colonization.

UV sterilization bulb in univent cabinet of room B116

7. Consider discontinuing the use of UV lamps in B116 univent to reduce possible exposure to ozone, a known lung irritant. Proper remediation of the source of odor should render these bulbs unnecessary.

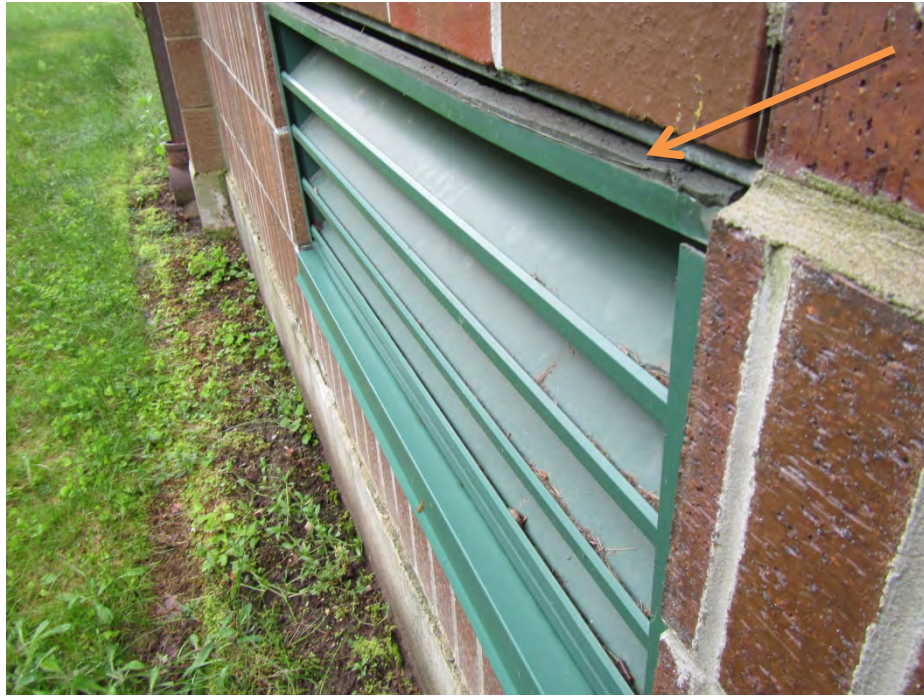
Picture 5

In order for building materials to support mold growth, a source of water exposure is necessary. Although no evidence of active water leaks was immediately apparent in B116, BEH staff did observe several sources of possible moisture. The exterior fresh air intake for the univent appeared to be ajar and protruded past the brick-framed opening (Picture 5). This condition allows the vent to “catch” rain/storm water and direct it towards the interior. There were several weep-holes in the brickwork immediately above this protruded intake vent. This flow from the weep-holes may add additional water onto the protruded vent frame and toward the interior of the univent. BEH staff also noted the lack of caulking and several gaps along the intake vent frame for water to infiltrate (Pictures 6 and 7).

Room B116 fresh air intake vent protruding out past brick frame

2. Thoroughly clean all *nonporous* surfaces within the univent and surrounding area of any dust/debris.
3. Inspect the fresh air intake vent for room B116 leading to the exterior and clean this vent thoroughly. Also, properly seat the vent cover so that it does not protrude and collect rain water. Any gaps around this vent should be tightly sealed with waterproof caulking.

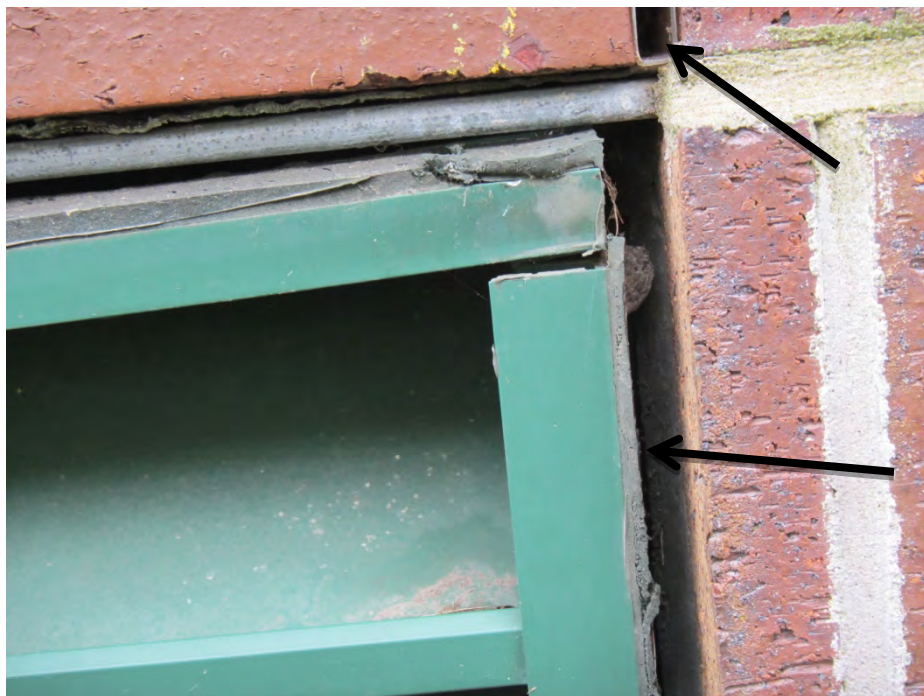
Picture 6

Univent intake vent showing weep hole above and lack of caulking on side

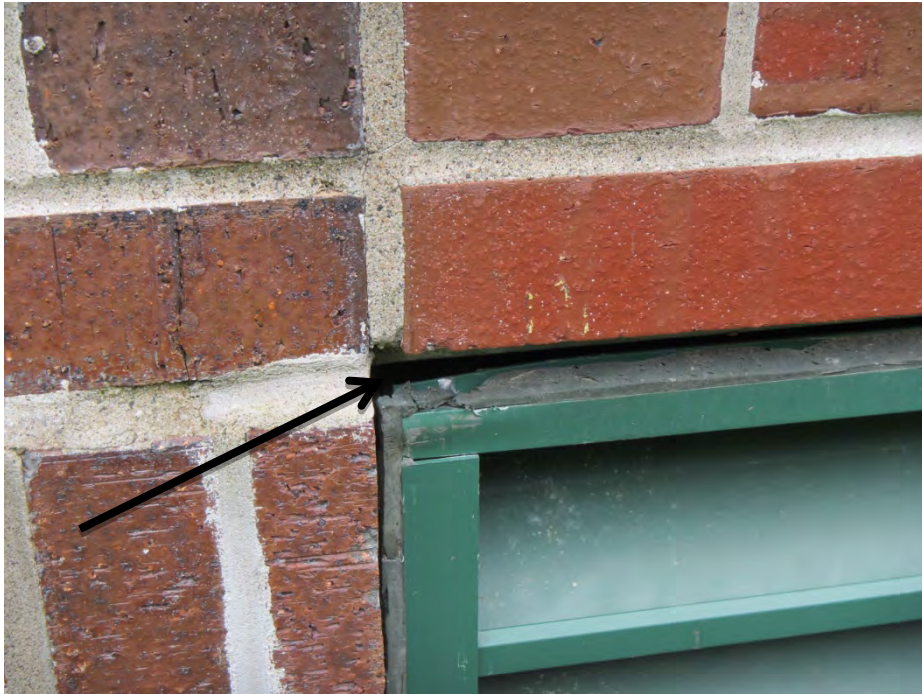
Picture 7

Ajar fresh air intake vent showing large gaps and missing caulking

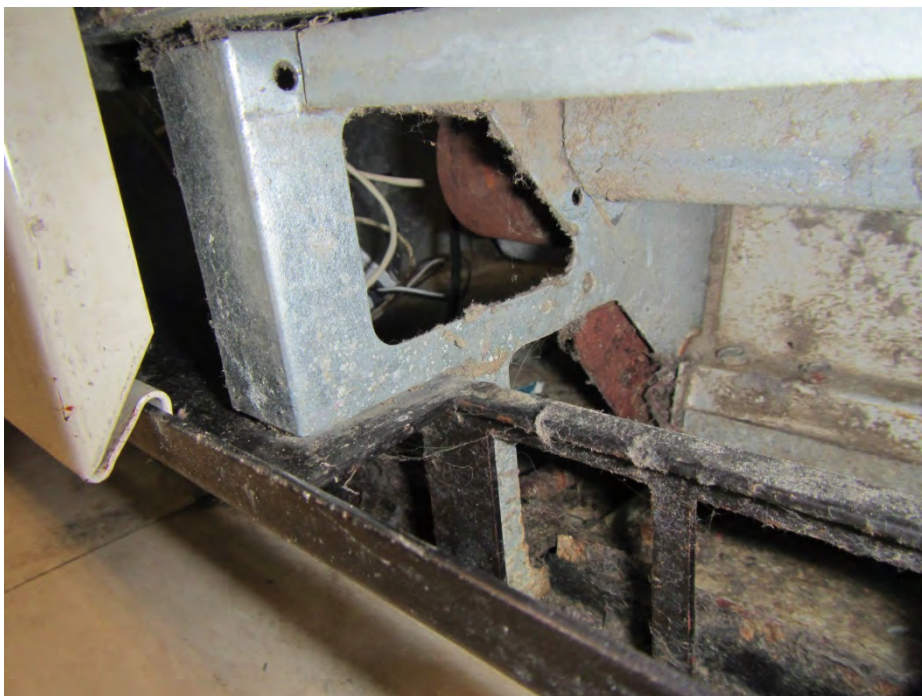
Picture 8

The univent in room B116 was opened and examined. BEH staff noted pathways within the univent for this moisture to travel. It was noted that the univent cabinet had multiple gaps/holes in the cabinet facing the exterior wall and within the univent itself. The bottom of the univent did not have adequate separation between the return vent and the unconditioned univent controls compartment which leads to the large hole at the back of the unit facing the exterior wall (Pictures 8 and 9). This condition allows the return vent to draw unconditioned air from the control side of the cabinet as well as from the behind the unit (through the large hole) and behind the shelving (Picture 10). Together these conditions may allow water or condensation to accumulate within debris in the cabinet (Picture 11) or in materials behind or next to the cabinet (e.g., wood/particle board shelving). These materials would then be subject to microbial colonization. Sometimes the wood/varnishes used in furniture/shelving will give off odors when moistened adding to the complexity of the odor.

Large gaps in univent wall separating unit return vent from unconditioned controls cabinet

1. When building is unoccupied, remove univent from wall in room B116. Discard all water-damaged porous materials in the univent (e.g., foam insulation, paper, and filter) and water-damaged materials adjacent to the unit (e.g., shelving, books, papers). For more information on mold refer to the US EPA's "Mold Remediation in Schools and Commercial Buildings". Available at: <http://www.epa.gov/mold/mold-remediation-schools-and-commercial-buildings-guide>

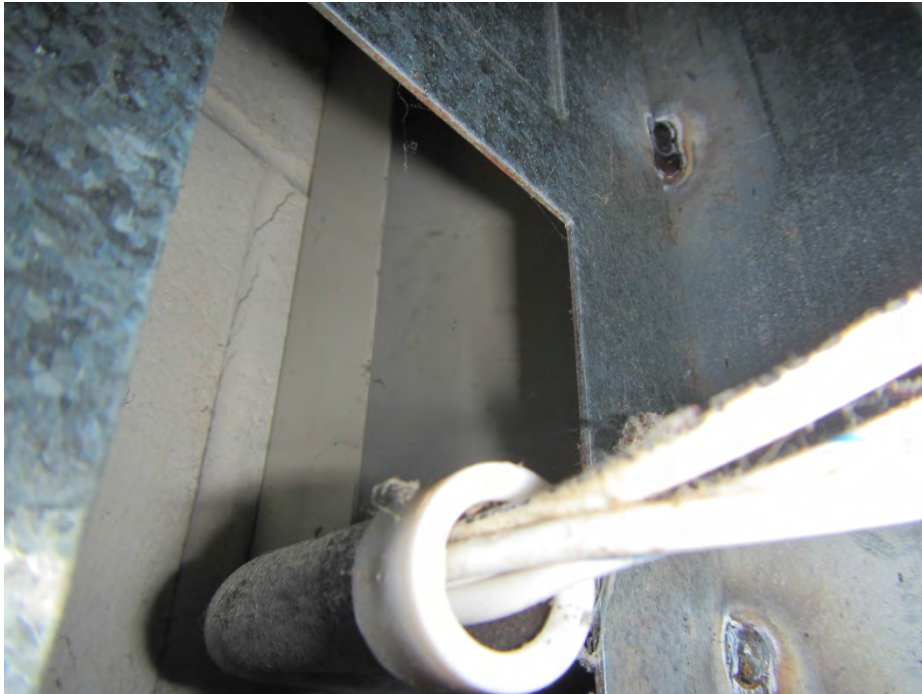
Picture 9

Large gap in univent cabinet facing exterior wall

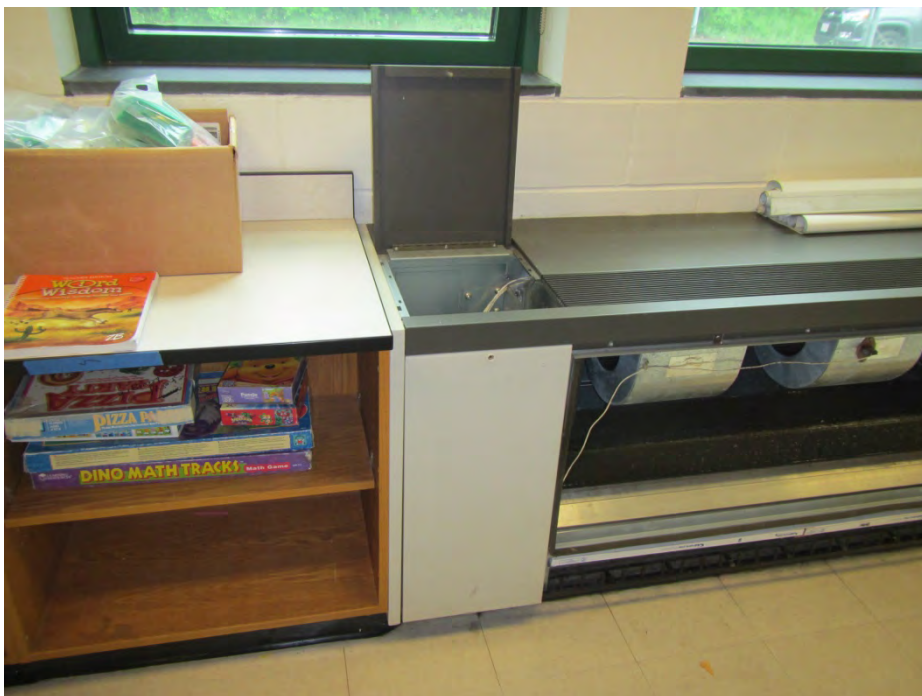
Picture 10

Since the univent cabinet appears to be the source for water vapor in classroom B116, any materials in or near the univent should be closely examined during the remediation effort. This would include examining any items or building materials in the univent cabinet as well as adjacent to/behind the unit. A thorough and professional cleaning of all nonporous univent surfaces is recommended inside and outside of the unit. The discarding of any porous materials (e.g., foam insulation, paper, and filter) within the unit is further recommended to reduce the likelihood of continued colonization. All holes and gaps leading to unconditioned areas should be sealed and the unit should be reinsulated fully to separate the conditioned compartments from unconditioned compartments/areas. Manufacturer recommendations should be followed for the specific unit being serviced.

Shelving and items adjacent to univent in room B116

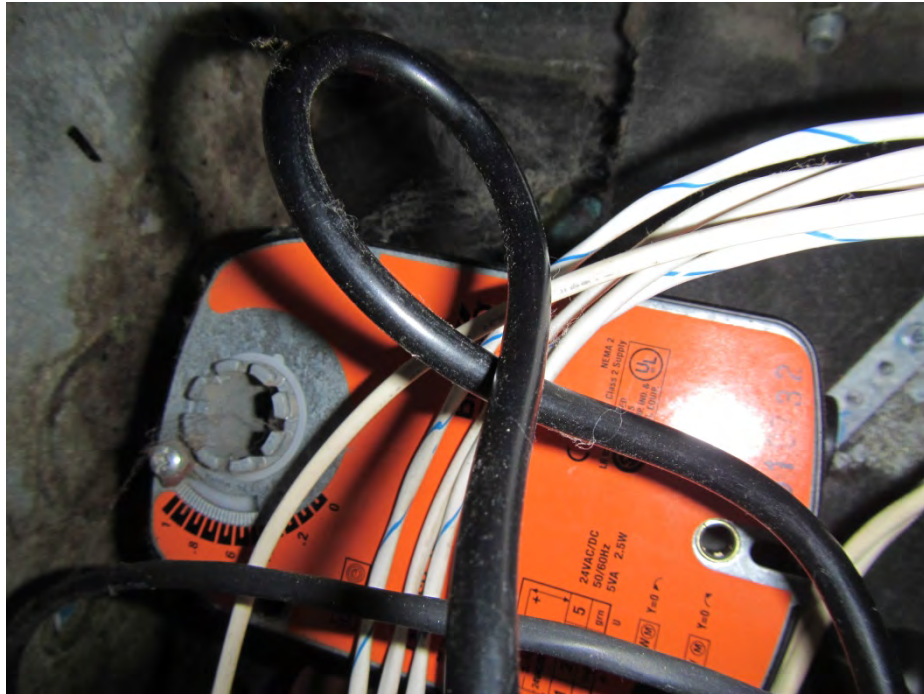
Picture 11

Accumulated dust/debris in cabinet of univent is subject to microbial colonization

18. Regularly clean/vacuum univent cabinets, supply/return vents and fans to avoid aerosolizing accumulated particulate matter.
19. Replace tennis balls with non-latex chair glides to avoid possible irritation or allergic reactions.

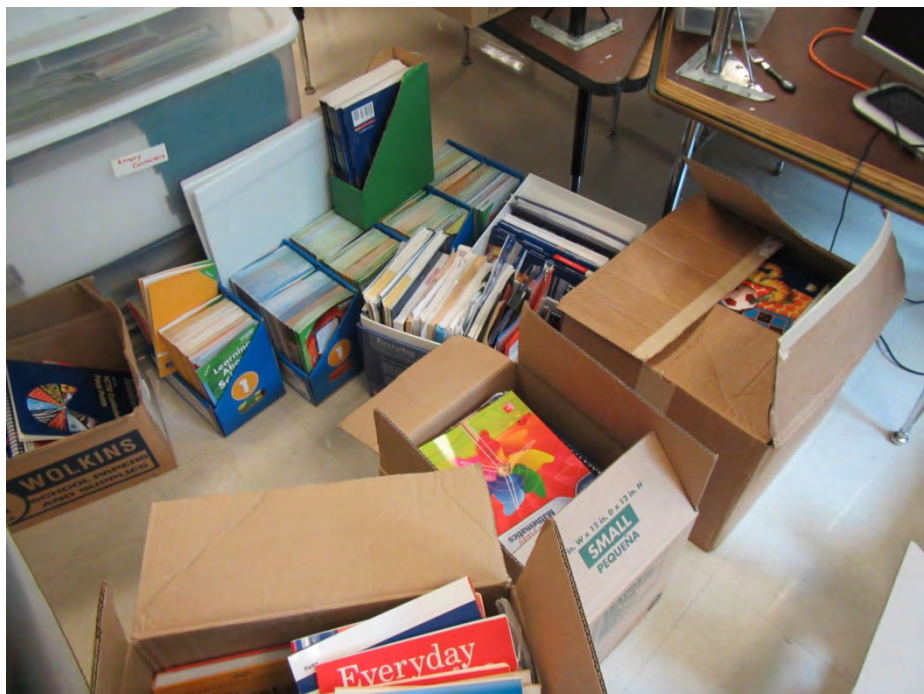
Picture 12

Using a moisture meter, BEH staff observed elevated moisture in floors in room B116 at the time of assessment. It was also reported by RES staff that the adjacent building wing has a problem with floors tiles popping up due to moisture. B116 is a slab on grade with floor tiles which is generally not conducive to microbial growth. However, there were numerous boxes, books, and containers stored directly on the slab floor (Picture 12). Porous items such as papers, cardboard, clothing, etc. may become colonized with mold if subjected to chronic moisture such as condensation from warm air coming in contact with the cooler slab. Condensation will form on surfaces that are cooled below the dew point temperature. This underlines the importance of sealing gaps/holes to unconditioned areas and within the univent cabinet itself. Moisture within the slab can also be increased by poor drainage around the slab perimeter and roof drainage issues.

Large amount of porous items stored directly on slab floor

10. Store boxes/porous items on shelving or pallets and not directly on floors especially slab floors which are at higher risk for condensation.
11. Regularly clean bins/stored items and flat surfaces by wet wiping them to avoid irritant effects of dust/debris. Refrain from bringing in porous items that were stored in unconditioned areas (e.g., basements, attics, garages).

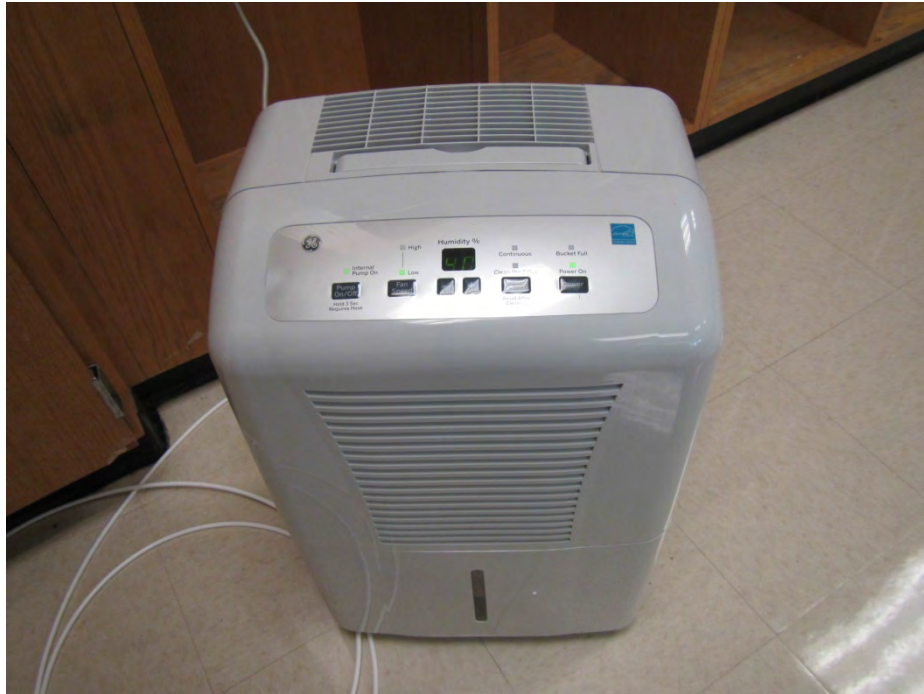
Picture 13

BEH staff observed dehumidifier units in both room B116 and the Library (Picture 13). These units are helpful in removing excess moisture in the air but must be maintained according to manufacturer recommendations to avoid microbial colonization within the units.

Dehumidifier in room B116

12. Maintain dehumidifiers according to manufacturer recommendations to avoid microbial colonization with the unit or filter.
13. Consider adopting a balancing schedule of every 5 years for all mechanical ventilation systems, as recommended by ventilation industrial standards (SMACNA, 1994).

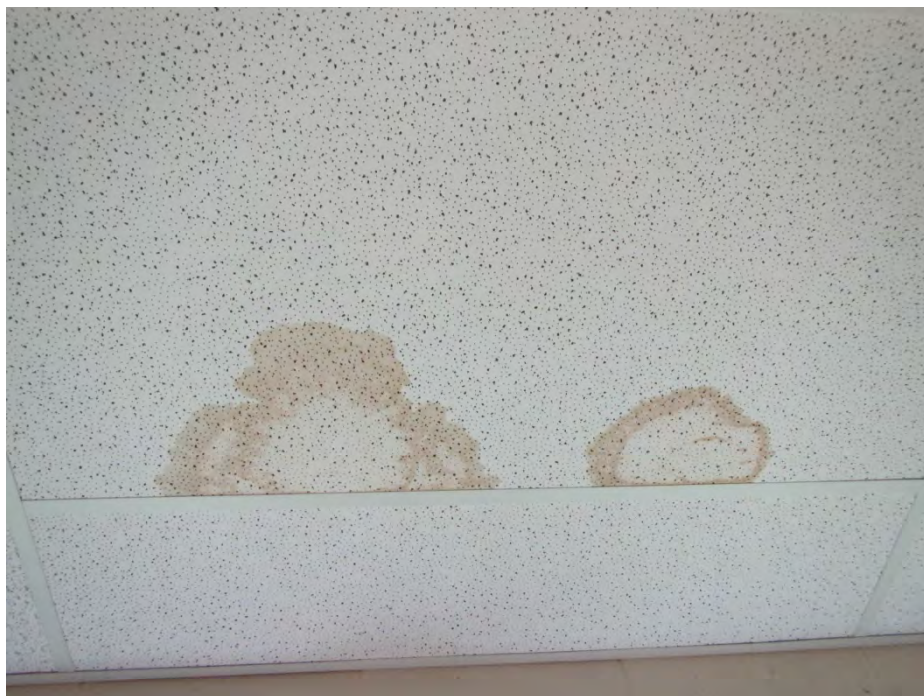
Picture 14

A few water-damaged ceiling tiles were observed in the Library (Picture 14), which indicate leaks from the building envelope or plumbing system. These ceiling tiles should be replaced after the leak is found and repaired.

Water-damaged ceiling tiles in Library

14. Ensure roof and plumbing leaks are repaired and replace water-damaged ceiling tiles in Library.
15. Properly maintain plants, including drip pans, to prevent water damage to porous materials. Plants should also be located away from air diffusers to prevent the aerosolization of dirt, pollen, and mold.

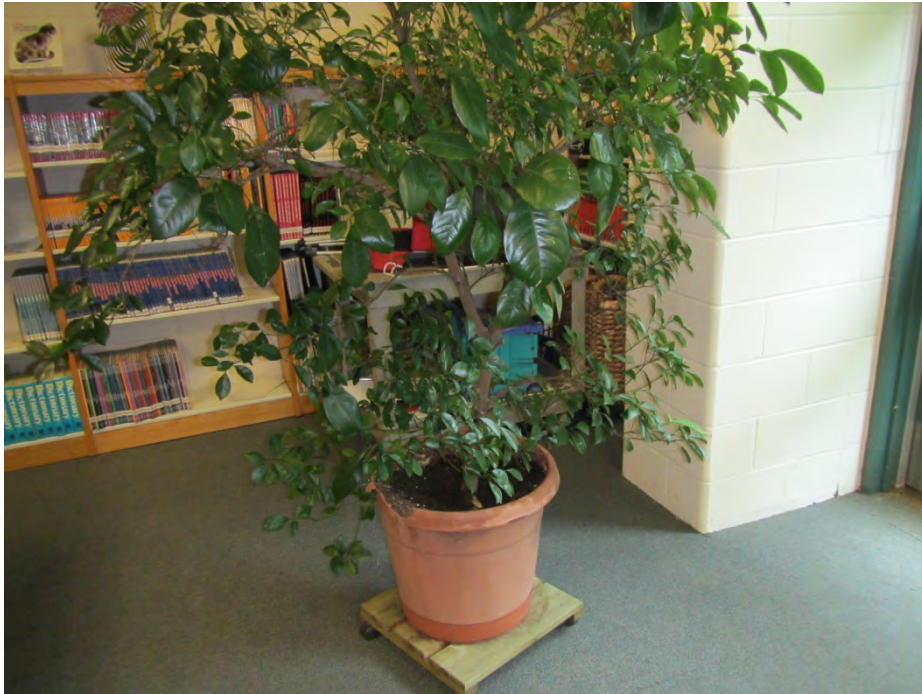
Picture 15

Plants were observed in a few areas (Picture 15). Plants can be a source of pollen and mold, which can be respiratory irritants to some individuals. Plants should be properly maintained and equipped with drip pans and should be located away from air diffusers to prevent the aerosolization of dirt, pollen and mold.

Plant located in Library

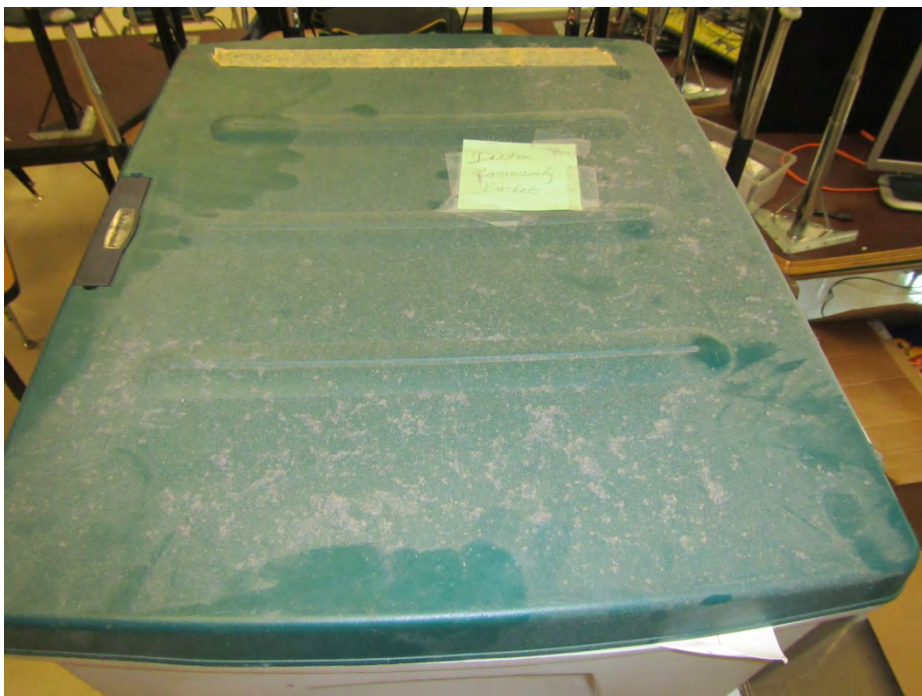
Picture 16

Classroom B116 was noted to have a large amount of stored items in boxes and plastic containers (Picture 16). Many of these boxes had a large accumulation of dust/debris. If aerosolized, this dust may have irritant effects.

Accumulated dust on stored items in B116

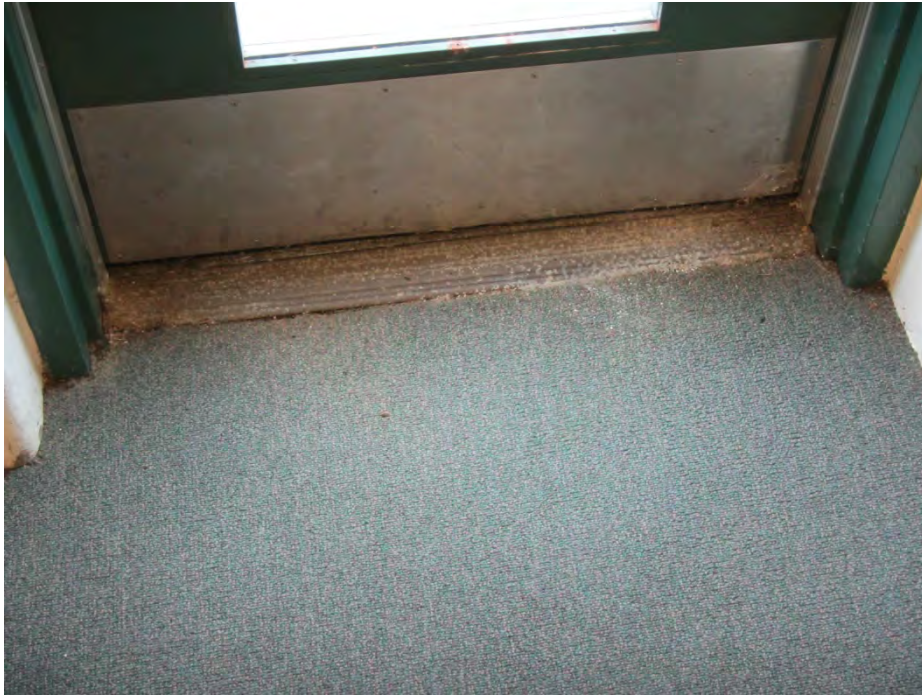
Picture 17

The Library had carpeting that appeared to be dated. The usable life of carpeting in schools is approximately 10-11 years (IICRC, 2002). Exterior doors leading to the Library lacked a weather proof entrance matt or carpet. As a result, dirt/debris and moisture have been allowed to periodically collect in these entrances (Picture 17). This will lead to accelerated carpet degradation and possible aerosolization of the dust/debris. Carpeting should be cleaned annually or semi-annually in soiled high traffic areas as per the recommendations of the Institute of Inspection, Cleaning and Restoration Certification (IICRC, 2012).

Library exit lacking entrance mat (note accumulated debris at threshold)

16. Install weatherproof entry carpets or mats to protect carpeting in the Library from being chronically moistened and rapidly worn.
17. Reduce use of products containing VOCs; only use in well-ventilated areas.

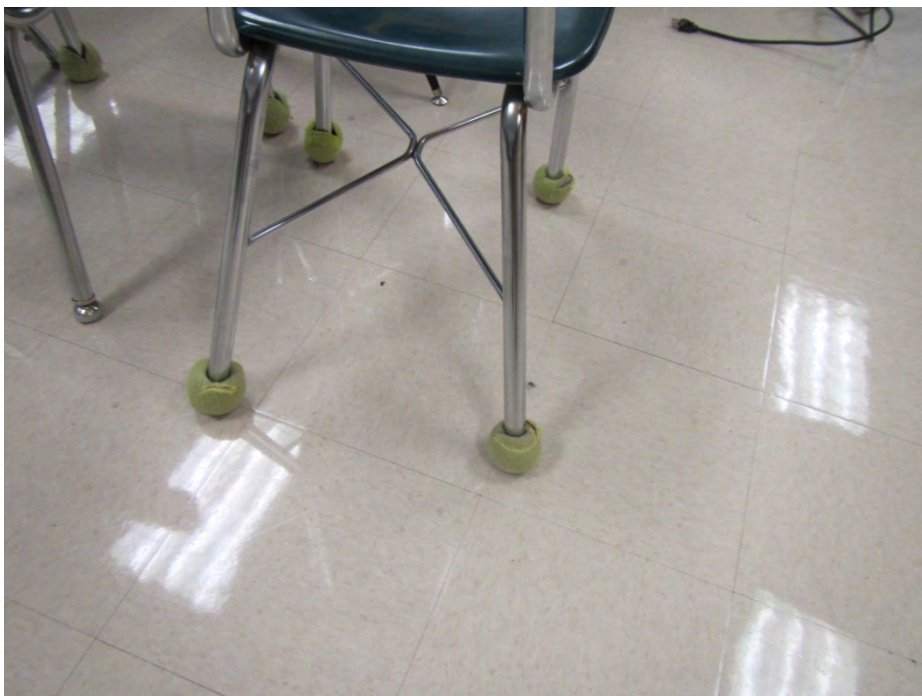
Picture 18

Tennis balls had been sliced open and placed on chair footings to reduce noise (Picture 18). Tennis balls are made of a number of materials that are a source of respiratory irritants. Constant wearing of tennis balls can produce fibers and lead to off-gassing of VOCs. Tennis balls are made with a natural rubber latex bladder, which becomes abraded when used as a chair leg pad. Use of tennis balls in this manner may introduce latex dust into the school environment. Some individuals are highly allergic to latex (e.g., spina bifida patients) (SBAA, 2001). It is recommended that the use of materials containing latex be limited in buildings to reduce the likelihood of symptoms in sensitive individuals (NIOSH, 1997; NIOSH, 1998).

Tennis balls used as chair glides in room B116
